Fact sheet | Urunga Wetlands

The Urunga Wetlands site is now a valuable community space following a \$10 million program of extensive remediation and parkland work. It has been transformed from a once barren wasteland to a lively wetland habitat.

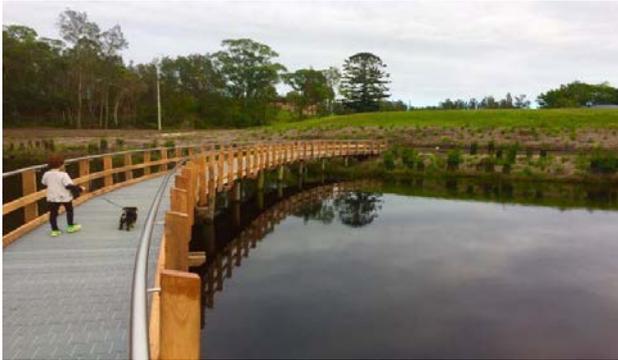
Timber boardwalk over Urunga Wetlands

A great destination for locals and visitors to the region, the site has a 150 metre boardwalk allowing people to walk over the wetland and a 450 metre walking track surrounding the park.

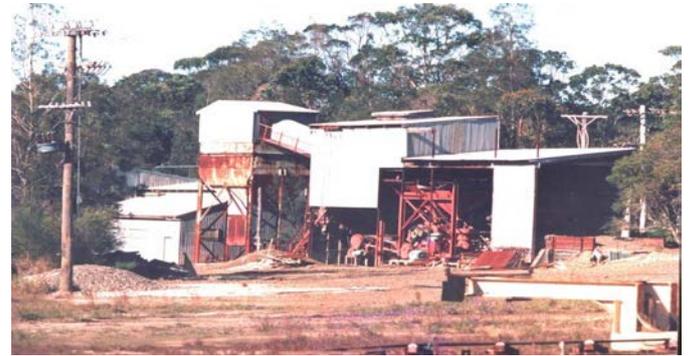
The old antimony processing plant (circa 1980)

The processing plant was used for extracting heavy metal antimony from its ore, stibnite.

After the ore was delivered to the site, it was crushed and the antimony removed using complex chemical reagents and equipment.

The antimony processing required large volumes of water, which was released after use onto the adjoining wetland foreshore.

These waste tailings were rich in heavy metals including antimony, arsenic, lead and reagent residues of cyanide and cresylic acid.

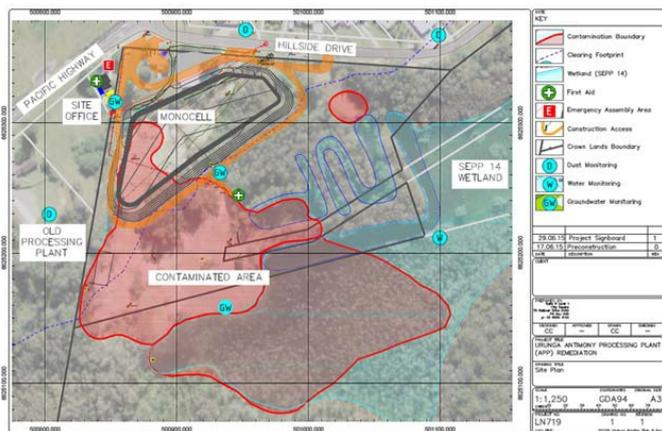
Site plan showing the contaminated area

Around four hectares of land needed excavation. Half of the land was in the wetland and half on dry land. A total of 36,400 tonnes of contaminated soils and sediments was removed.

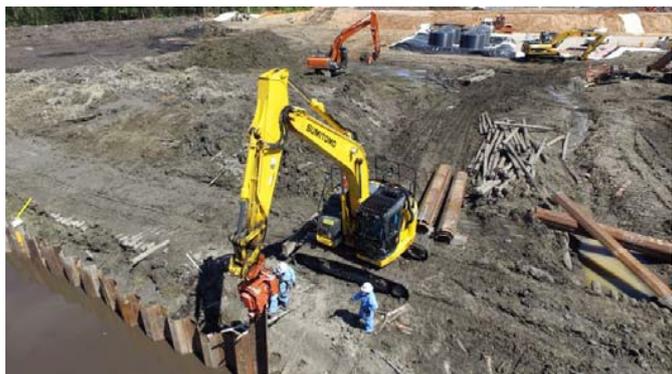
Installing a sheet pile wall to hold back the wetland water

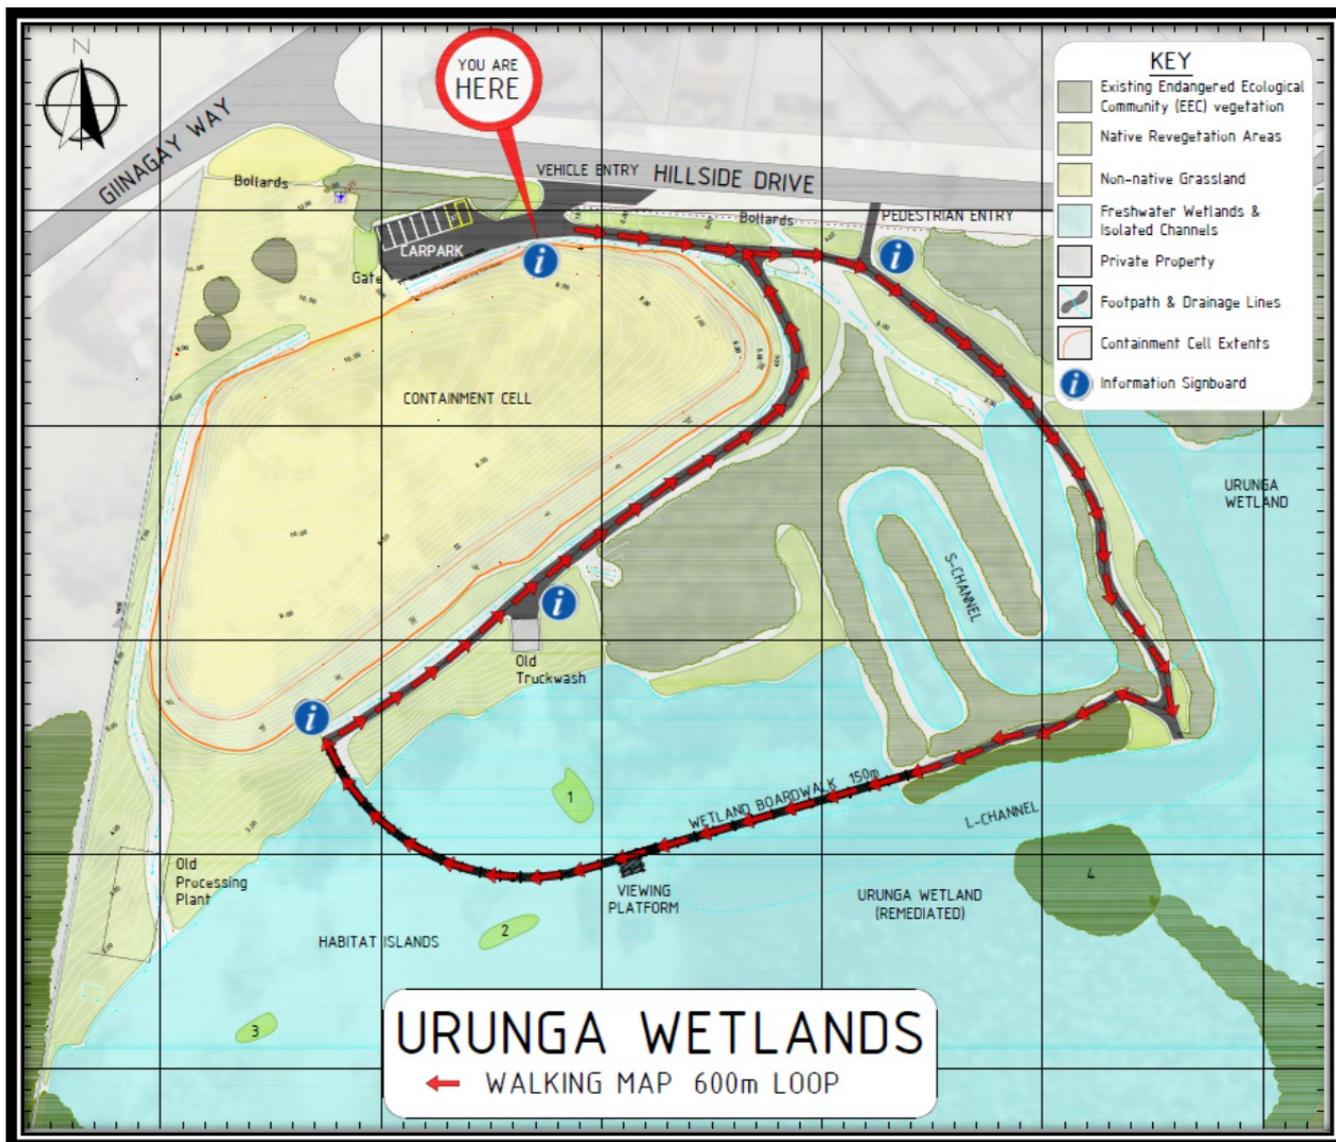
Walking trail around Urunga Wetlands

The walking trail around Urunga Wetlands takes you in a 600 metre circuit from the carpark, down to the water’s edge and across the boardwalk back up past the containment cell, which looks like a grassy mound.
