Update - Menindee Groundwater Investigations

February 2016

Lake Menindee bore field

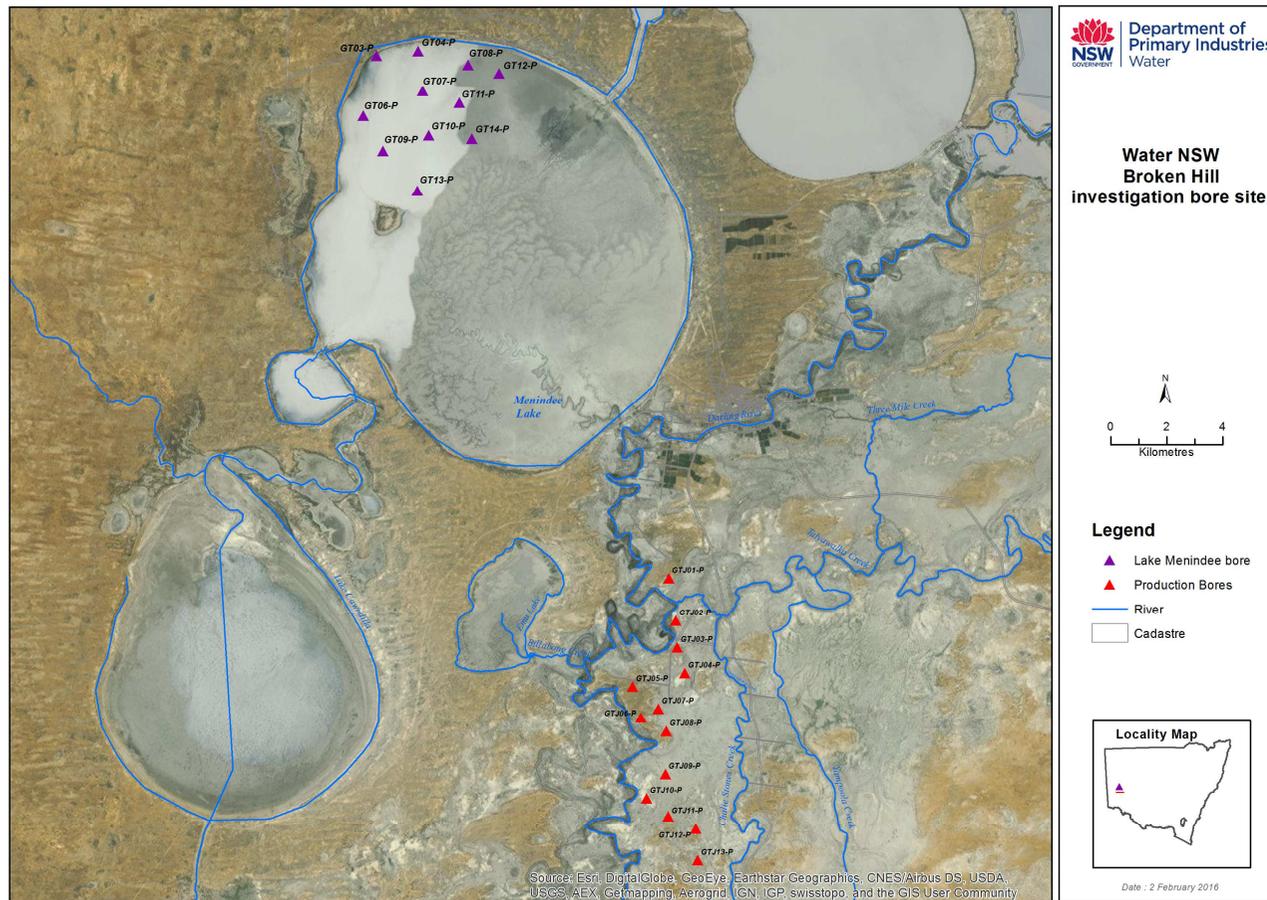
Figure 1: Location of drilling sites included in the REF

WaterNSW has constructed 11 production bores on the bed of Lake Menindee (see **Figure 1**). These bores target a shallow, low salinity sand aquifer (Calivil Formation) under the northern part of the lake bed.

WaterNSW has constructed 13 production bores in the Talyawalka bore field (see **Figure 1**). These bores target a low salinity sand aquifer that underlies the Darling River floodplain.
